Inspection Report

John and Mary Sample

Property Address:
123 Main St.
Boston MA 02108

Mystic Home Inspection, LLC

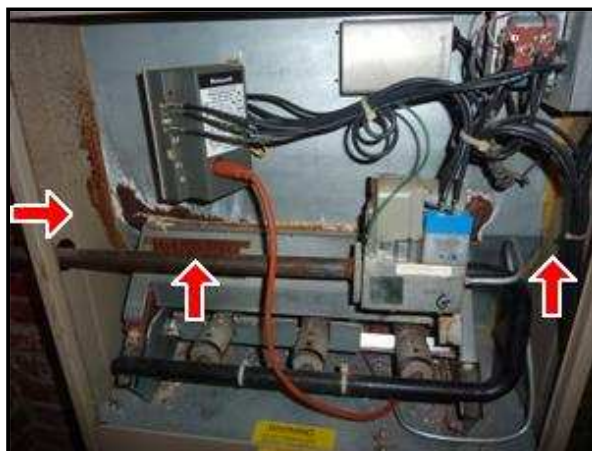
1.0 (1) The furnace is aged (manufactured and installed in 1984) and is past its average life expectancy. The unit worked at time of inspection, but I am unable to determine life remaining. The unit may fail at any time in the near future. I recommend that the unit be serviced and cleaned and including an examination of the heat exchanger for leaks. Emphasizing the importance of this service is the rust that was visible when the access cover was removed (See Picture 1). If the heat exchanger has leaks, replacement will be necessary. Consult HVAC contractor for service.

1.0 Picture 1 Rust under cover of furnace

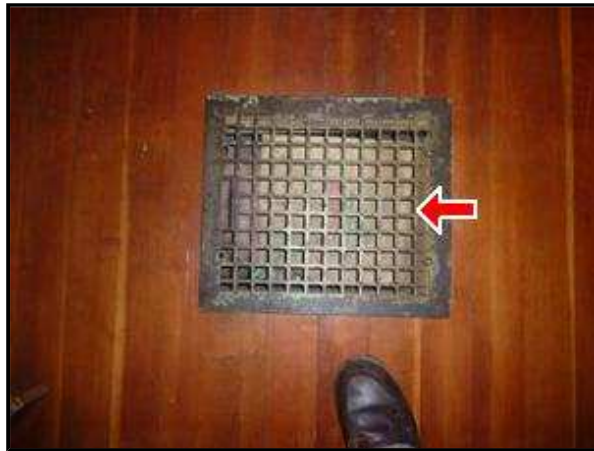
1.4 (1) There is an abandoned register in the dining room. This opening can provide a path for fire and also allow basement odors to rise into the living space. I recommend sealing this hole in the floor. Refinish the wood floor as desired.

1.4 Picture 1 Abandoned register

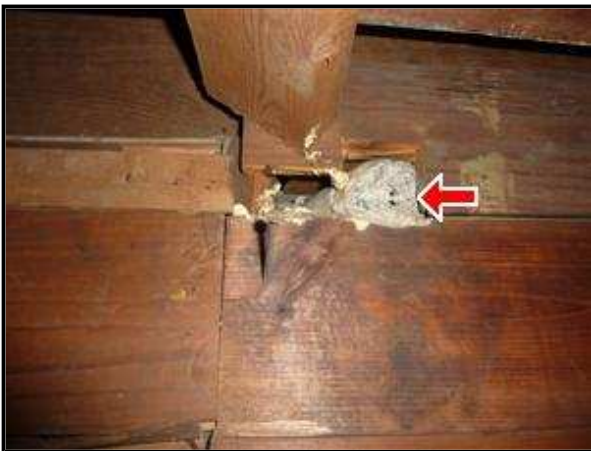
(2) Insulation left over from the old hydronic heating system was seen. If this is asbestos, care must be taken with any renovation projects. An asbestos abatement company will be required to remove any that is found. Note that home inspectors do not test for asbestos since laboratory analysis is required, so can not confirm its chemical makeup.

1.4 Picture 2 Possible asbestos

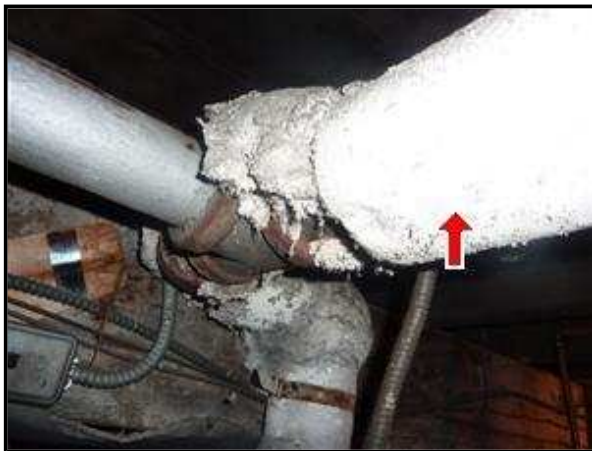
1.4 Picture 3 Frayed pipe insulation

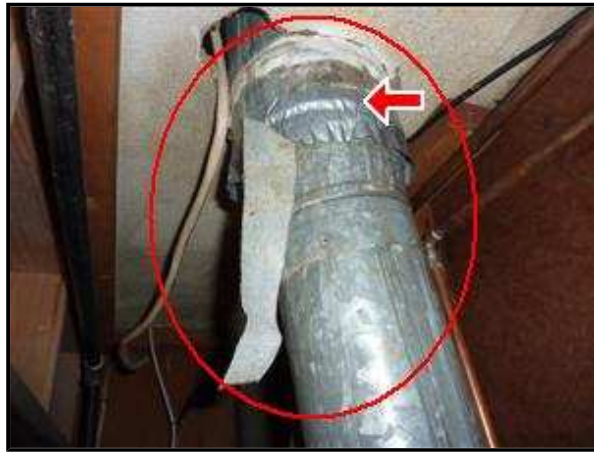
(3) Fabric duck tape was used to seal gaps in the metal flue pipe. This is improper material for this use, since it does not withstand heat. Here the tape has failed and is falling off. I recommend having an HVAC professional make necessary changes to the flue pipe to insure the health and safety of the occupants.

1.4 Picture 4 Duck tape on exhaust flue

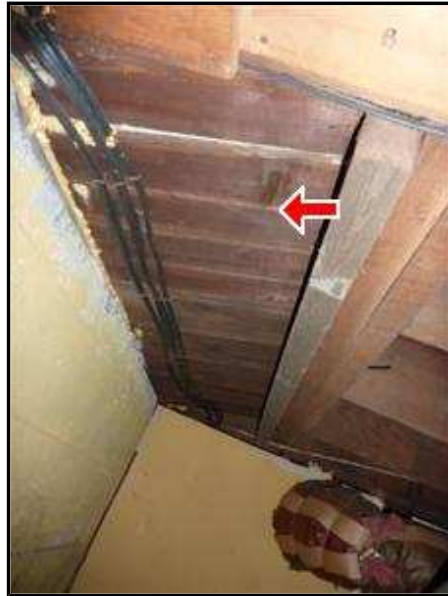
1.6 (1) The wood forms are still present under the hearth extension when viewed from the basement. This is a fire hazard. I recommend removal of the wood forms.

1.6 Picture 1 Wood forms under hearth extension

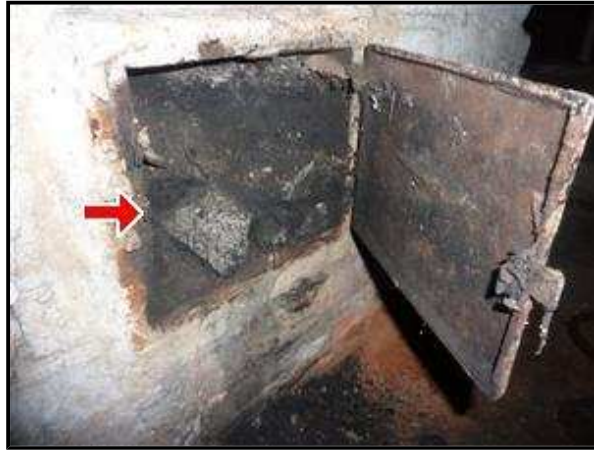
1.6 Picture 2

(3) The fireplace/chimney cleanout was packed full with debris. I could not determine how high the debris was piled in the flue. If the debris piles up high enough, it can block the furnace exhaust gases from properly going up the chimney and enter the home. This is a health-safety issue. I recommend having a chimney sweep perform a Level 2 inspection and cleaning prior to the next heating season.

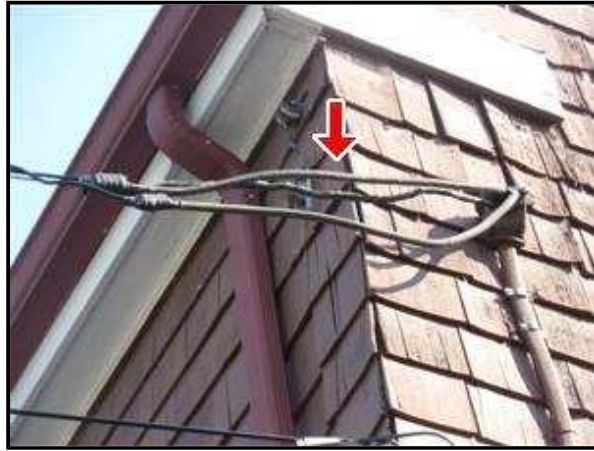
2.0 The service entrance cable has no drip loop that allows water to safely drip off the cables, and provides some buffer if something presses against the wires. In this case, a tree has grown and is pulling on the wires, which can lead to failure of the connections or can pull the service conduit off the building. This can lead to power outages or injury if the live wires come in contact with people or pets. Consult an electrician for repairs now.

2.0 Picture 1 Wires being pulled off house

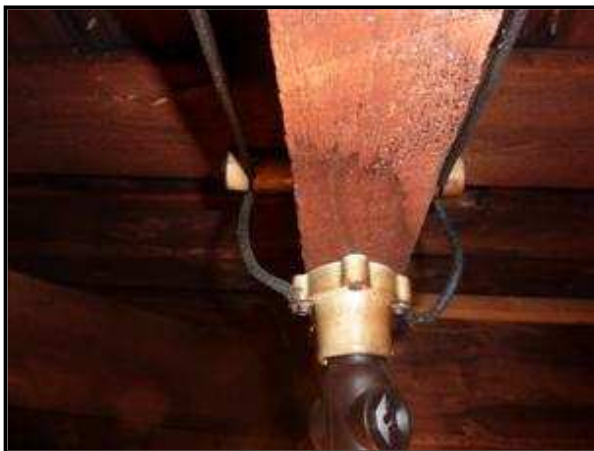
2.2 (1) There were circuits observed in the attic that are "knob & tube" wiring (Picture 2). This an old and obsolete type of branch wiring. This wiring typically has splices along unprotected sections of the wiring. It cannot have objects hanging from it, or insulation (and other objects) pressing against it. The wire insulation often falls off, leaving bare wires (Picture 5). If there are areas that have damage, pressure or other wear to the wiring, it can be dangerous. Splices made to this wiring may be made incorrectly or outside of junction boxes. This wiring also does not have a grounded conductor. Some outlets and fixtures may be fed by this wiring (Picture 1).

2.2 Picture 1 Knob and tube wiring

Keep in mind that some insurance companies do not provide new insurance policies or charge a surcharge for properties with knob and tube wiring. It is recommended that you verify with your insurer that you will be provided insurance. Replacement of all sections of active knob and tube wiring with modern grounded wiring is recommended. Consult an electrician for repairs.

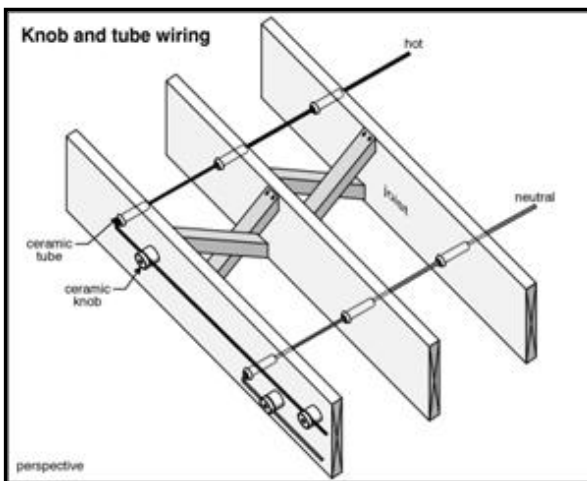
2.2 Picture 2 Knob & tube wiring diagram

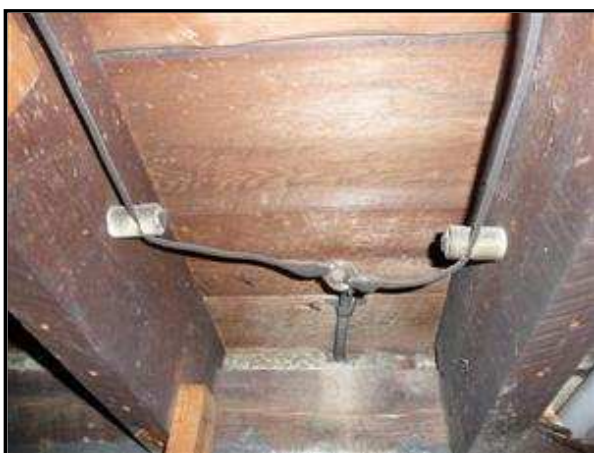
2.2 Picture 3 Knob & tube wiring in basement

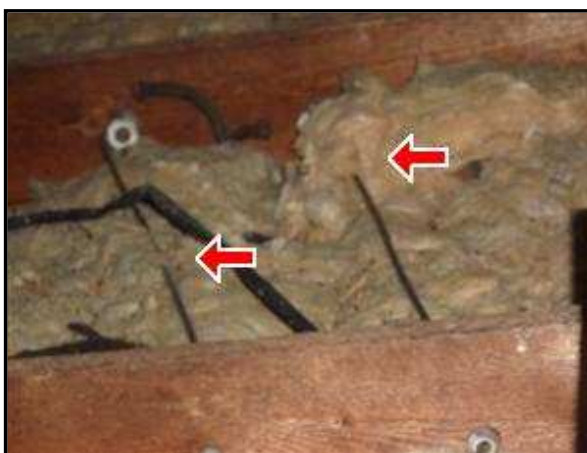
Furthermore, insulation has been added to the attic under the floor boards (Picture 4) and foam insulation can be seen pressing against the knob & tube wiring. Adding insulation against this old wiring is not allowed and is hazardous since this wiring requires air for cooling and the insulation is often old and cracking. The wires under the floor boards and in wall cavities could not be seen or inspected.

2.2 Picture 4 Knob and tube wires covered with insulation

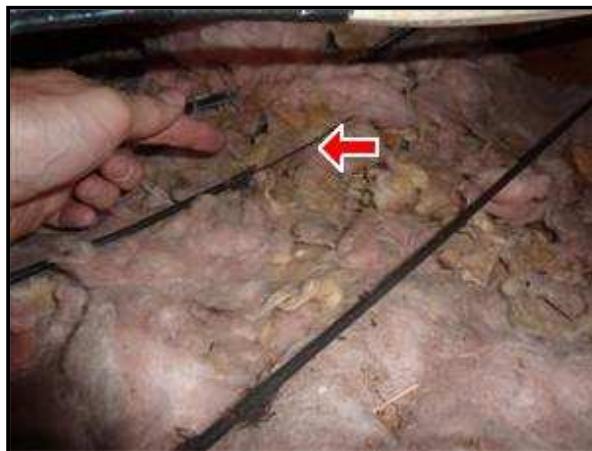
2.2 Picture 5 Bare, live wire

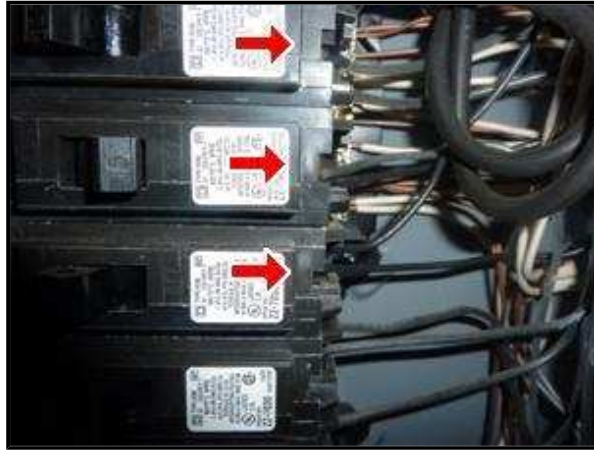
(2) Three (3) double tapped breakers were found in the main electric panel. The lugs were designed for one wire each. This situation can result in overloading and breaker tripping as well as overheating that can lead to fires. I recommend that an electrician make necessary repairs now.

2.2 Picture 6 Double tapped circuit breakers

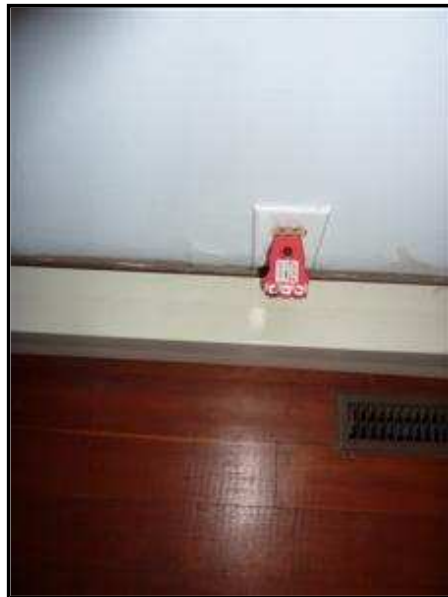
2.4 (1) One receptacle in the dining room was not grounded but was a three-pronged receptacle which suggests upgrade by an amateur. Because of this and the active knob and tube wiring in the attic, I recommend an electrician evaluate the branch wiring for ungrounded knob and tube wiring and replace it with modern wiring. Furthermore, remaining receptacles should be checked proper wiring when all of them are accessible.

2.4 Picture 1 Dining room: not grounded

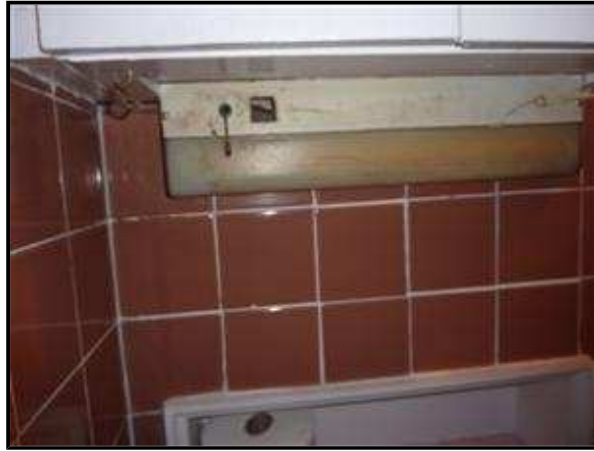
(2) This under-cabinet bathroom light does not work and has an old 2-prong outlet in it. I recommend removal and or replacement.

2.4 Picture 2 Obsolete light in bathroom

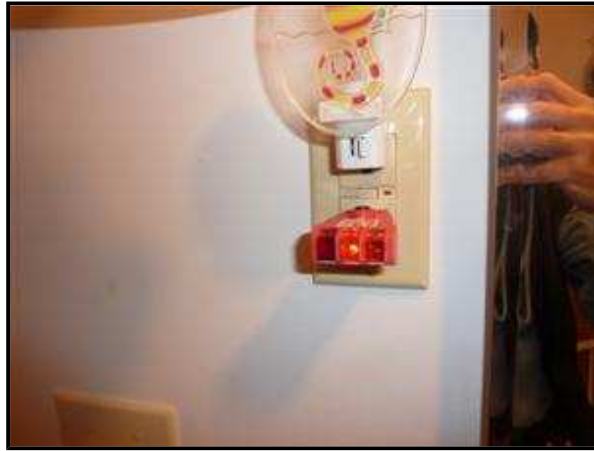
2.7 The bathroom GFCI receptacle is not functioning as designed. This is a safety issue. I recommend replacement by an electrician.

2.7 Picture 1 No ground detected
