Inspection Report

Property Address:
123 Main St.
Boston MA 02108

Mystic Home Inspection, LLC

Date: 4/13/2010	Time: 02:00 PM to 05:00 PM	Report ID: MYSTIC-SAMPLE
Property: 123 Main St. Boston MA 02108	Customer: John and Mary Sample	Real Estate Agent:

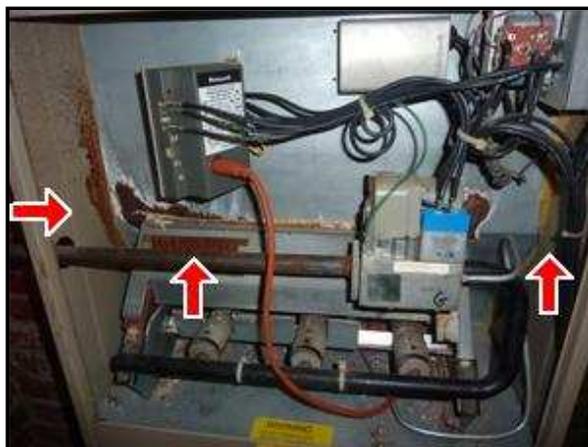
(1) The furnace is aged (manufactured and installed in 1984) and is past its average life expectancy. The unit worked at time of inspection, but I am unable to determine life remaining. The unit may fail at any time in the near future. I recommend that the unit be serviced and cleaned and including an examination of the heat exchanger for leaks. Emphasizing the importance of this service is the rust that was visible when the access cover was removed (See Picture 1). If the heat exchanger has leaks, replacement will be necessary. Consult HVAC contractor for service.

1.0 (1) The furnace is aged (manufactured and installed in 1984) and is past its average life expectancy. The unit worked at time of inspection, but I am unable to determine life remaining. The unit may fail at any time in the near future. I recommend that the unit be serviced and cleaned and including an examination of the heat exchanger for leaks. Emphasizing the importance of this service is the rust that was visible when the access cover was removed (See Picture 1). If the heat exchanger has leaks, replacement will be necessary. Consult HVAC contractor for service.

1.0 Picture 1 Rust under cover of furnace

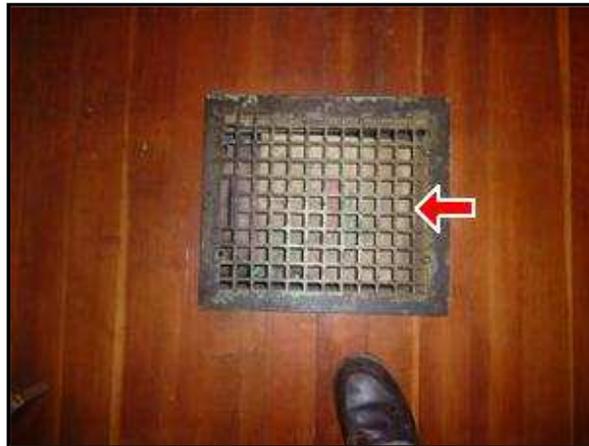
(1) There is an abandoned register in the dining room. This opening can provide a path for fire and also allow basement odors to rise into the living space. I recommend sealing this hole in the floor. Refinish the wood floor as desired.

1.4 (1) There is an abandoned register in the dining room. This opening can provide a path for fire and also allow basement odors to rise into the living space. I recommend sealing this hole in the floor. Refinish the wood floor as desired.

1.4 Picture 1 Abandoned register

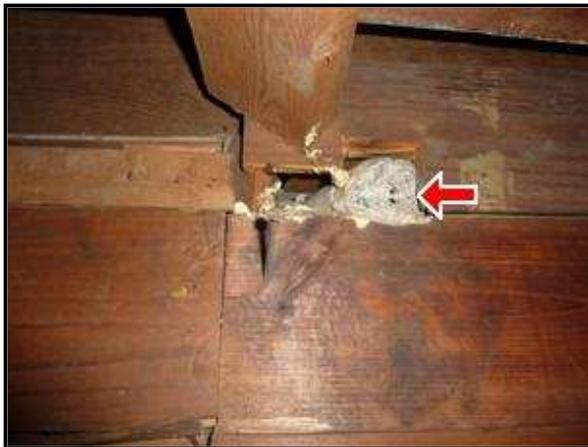
(2) Insulation left over from the old hydronic heating system was seen. If this is asbestos, care must be taken with any renovation projects. An asbestos abatement company will be required to remove any that is found. Note that home inspectors do not test for asbestos since laboratory analysis is required, so can not confirm its chemical makeup.

1.4 Picture 2 Possible asbestos

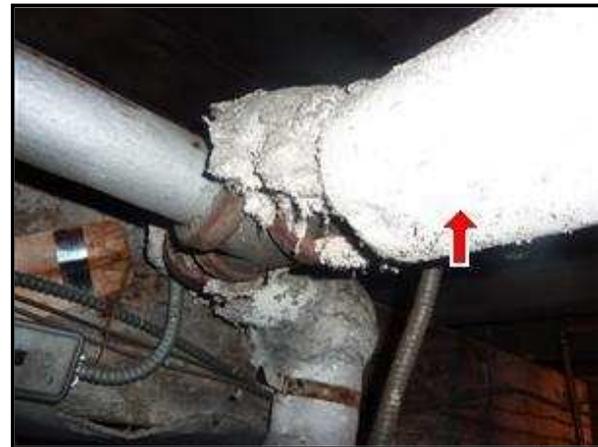
1.4 Picture 3 Frayed pipe insulation

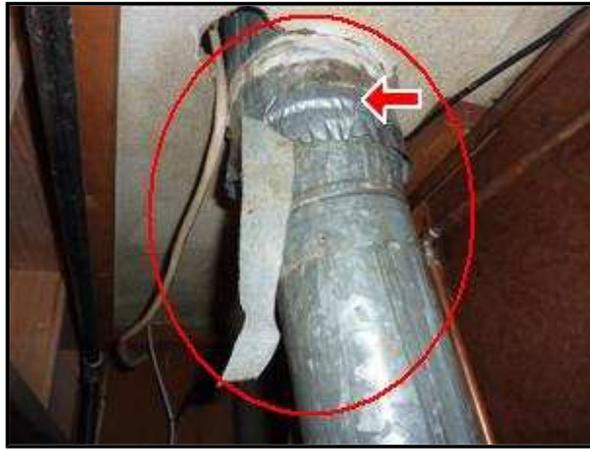
(3) Fabric duck tape was used to seal gaps in the metal flue pipe. This is improper material for this use, since

it does not withstand heat. Here the tape has failed and is falling off. I recommend having an HVAC professional make necessary changes to the flue pipe to insure the health and safety of the occupants.

(3) Fabric duck tape was used to seal gaps in the metal flue pipe. This is improper material for this use, since it does not withstand heat. Here the tape has failed and is falling off. I recommend having an HVAC professional make necessary changes to the flue pipe to insure the health and safety of the occupants.

1.4 Picture 4 Duck tape on exhaust flue

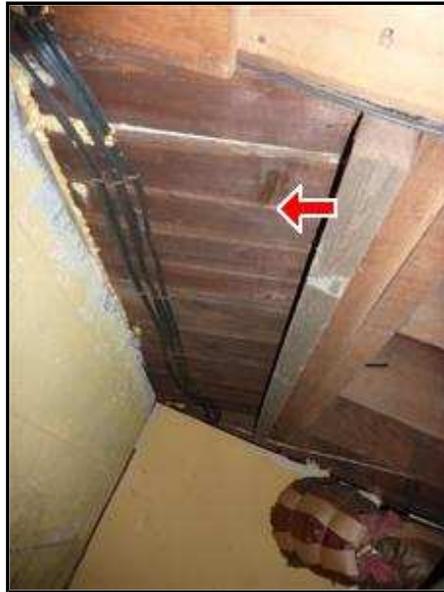
(1) The wood forms are still present under the hearth extension when viewed from the basement. This is a fire hazard. I recommend removal of the wood forms.

1.6 (1) The wood forms are still present under the hearth extension when viewed from the basement. This is a fire hazard. I recommend removal of the wood forms.

1.6 Picture 1 Wood forms under hearth extension

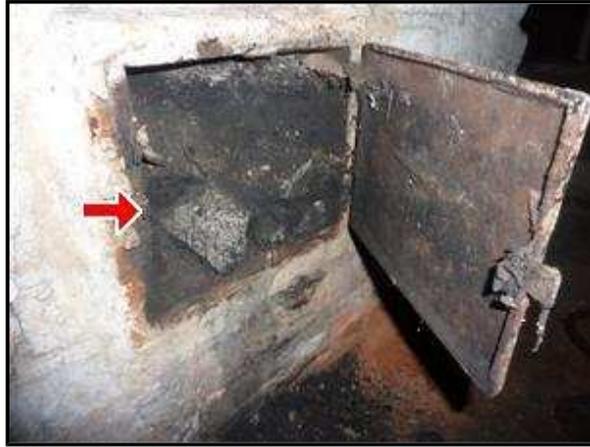
1.6 Picture 2

(3) The fireplace/chimney cleanout was packed full with debris. I could not determine how high the debris was piled in the flue. If the debris piles up high enough, it can block the furnace exhaust gases from properly going up the chimney and enter the home. This is a health-safety issue. I recommend having a chimney sweep perform a Level 2 inspection and cleaning prior to the next heating season.

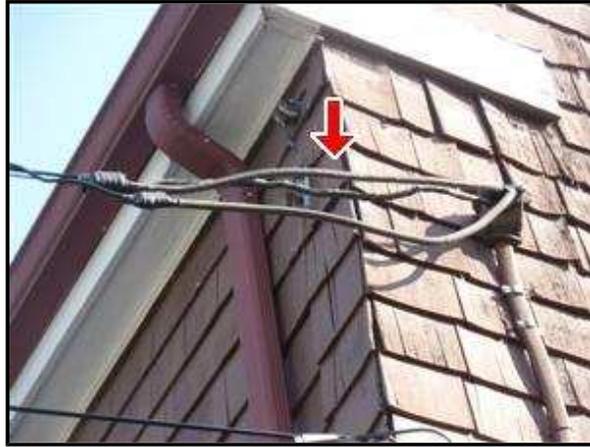
The service entrance cable has no drip loop that allows water to safely drip off the cables, and provides some buffer if something presses against the wires. In this case, a tree has grown and is pulling on the wires, which can lead to failure of the connections or can pull the service conduit off the building. This can lead to power outages or injury if the live wires come in contact with people or pets. Consult an electrician for repairs now.

2.0 The service entrance cable has no drip loop that allows water to safely drip off the cables, and provides some buffer if something presses against the wires. In this case, a tree has grown and is pulling on the wires, which can lead to failure of the connections or can pull the service conduit off the building. This can lead to power outages or injury if the live wires come in contact with people or pets. Consult an electrician for repairs now.

2.0 Picture 1 Wires being pulled off house

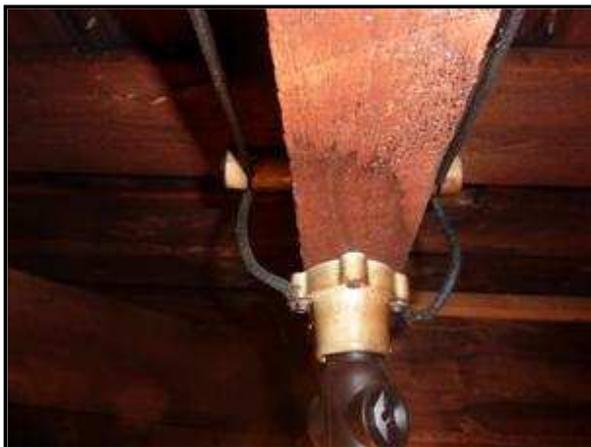
2.2 (1) There were circuits observed in the attic that are "knob & tube" wiring (Picture 2). This an old and obsolete type of branch wiring. This wiring typically has splices along unprotected sections of the wiring. It cannot have objects hanging from it, or insulation (and other objects) pressing against it. The wire insulation often falls off, leaving bare wires (Picture 5). If there are areas that have damage, pressure or other wear to the wiring, it can be dangerous. Splices made to this wiring may be made incorrectly or outside of junction boxes. This wiring also does not have a grounded conductor. Some outlets and fixtures may be fed by this wiring (Picture 1).

2.2 Picture 1 Knob and tube wiring

Keep in mind that some insurance companies do not provide new insurance policies or charge a surcharge for properties with knob and tube wiring. It is recommended that you verify with your insurer that you will be provided insurance. Replacement of all sections of active knob and tube wiring with modern grounded wiring is recommended. Consult an electrician for repairs.

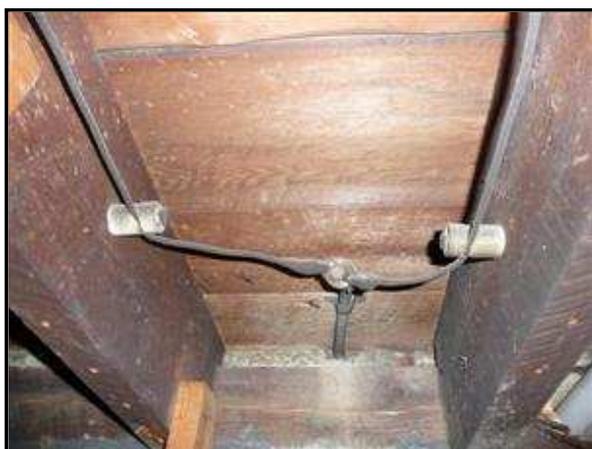
2.2 Picture 3 Knob & tube wiring in basement

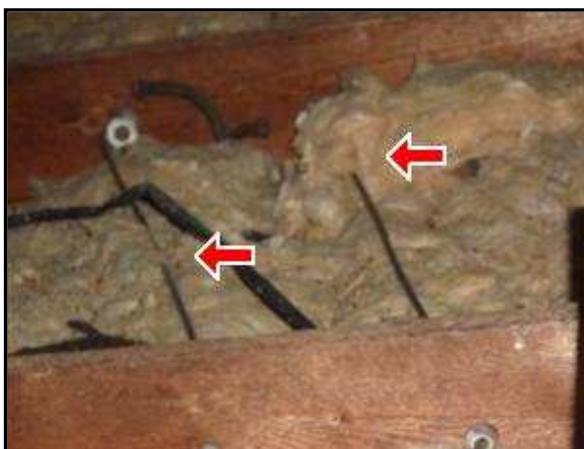
Furthermore, insulation has been added to the attic under the floor boards (Picture 4) and foam insulation can be seen pressing against the knob & tube wiring. Adding insulation against this old wiring is not allowed and is hazardous since this wiring requires air for cooling and the insulation is often old and cracking. The wires under the floor boards and in wall cavities could not be seen or inspected.

2.2 Picture 4 Knob and tube wires covered with insulation

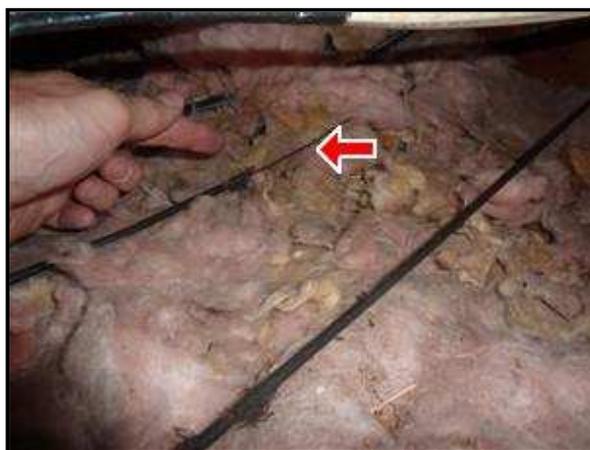
2.2 Picture 5 Bare, live wire

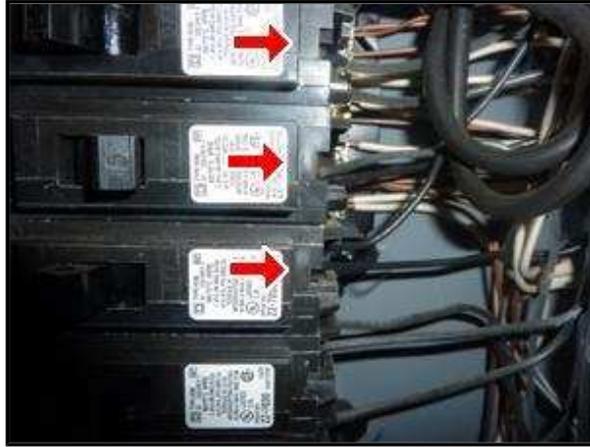
(2) Three (3) double tapped breakers were found in the main electric panel. The lugs were designed for one wire each. This situation can result in overloading and breaker tripping as well as overheating that can lead to fires. I recommend that an electrician make necessary repairs now.

2.2 Picture 6 Double tapped circuit breakers

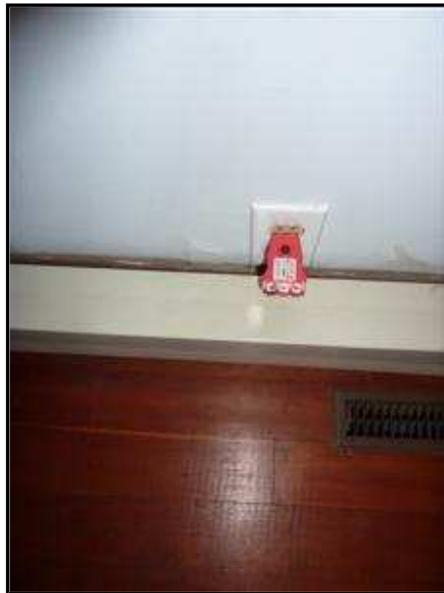
(1) One receptacle in the dining room was not grounded but was a three-pronged receptacle which suggests upgrade by an amateur. Because of this and the active knob and tube wiring in the attic, I recommend an electrician evaluate the branch wiring for ungrounded knob and tube wiring and replace it with modern wiring. Furthermore, remaining receptacles should be checked proper wiring when all of them are accessible.

2.4 (1) One receptacle in the dining room was not grounded but was a three-pronged receptacle which suggests upgrade by an amateur. Because of this and the active knob and tube wiring in the attic, I recommend an electrician evaluate the branch wiring for ungrounded knob and tube wiring and replace it with modern wiring. Furthermore, remaining receptacles should be checked proper wiring when all of them are accessible.

2.4 Picture 1 Dining room: not grounded

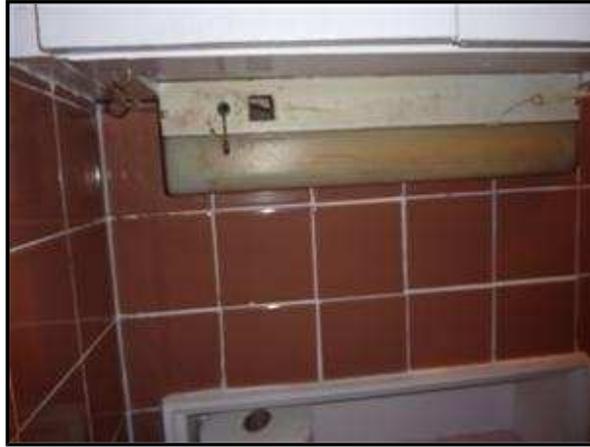
(2) This under-cabinet bathroom light does not work and has an old 2-prong outlet in it. I recommend removal and or replacement.

2.4 Picture 2 Obsolete light in bathroom

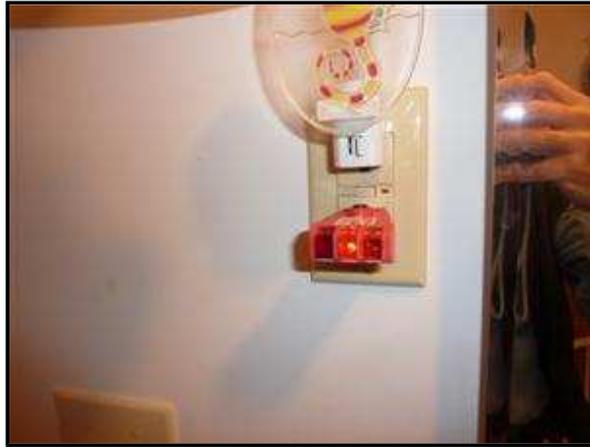
The bathroom GFCI receptacle is not functioning as designed. This is a safety issue. I recommend replacement by an electrician.

2.7 The bathroom GFCI receptacle is not functioning as designed. This is a safety issue. I recommend replacement by an electrician.

2.7 Picture 1 No ground detected
