Inspection Report

Property Address:
123 Main St.
Boston MA 02108

Mystic Home Inspection, LLC

Date: 4/13/2010	Time: 02:00 PM to 05:00 PM	Report ID: MYSTIC-SAMPLE
Property: 123 Main St. Boston MA 02108	Customer: John and Mary Sample	Real Estate Agent:

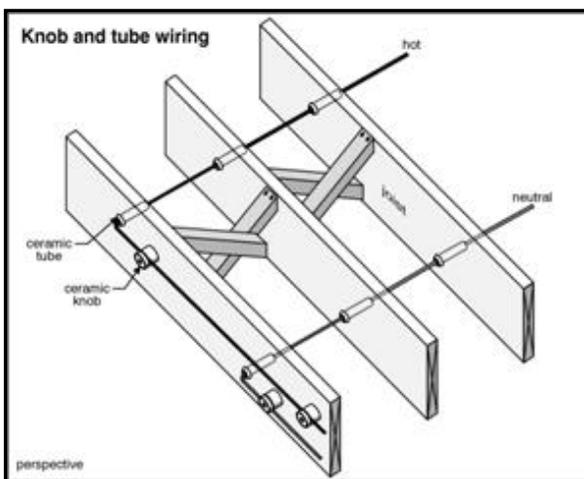
2.2 (1) There were circuits observed in the attic that are "knob & tube" wiring (Picture 2). This an old and obsolete type of branch wiring. This wiring typically has splices along unprotected sections of the wiring. It cannot have objects hanging from it, or insulation (and other objects) pressing against it. The wire insulation often falls off, leaving bare wires (Picture 5). If there are areas that have damage, pressure or other wear to the wiring, it can be dangerous. Splices made to this wiring may be made incorrectly or outside of junction boxes. This wiring also does not have a grounded conductor. Some outlets and fixtures may be fed by this wiring (Picture 1).

2.2 Picture 2 Knob & tube wiring diagram
